UPPER GILA RIVER FLUVIAL GEOMORPHOLOGY STUDY

GEOMORPHIC ANALYSIS ARIZONA

US Department of the Interior
Bureau of Reclamation

DECEMBER 31, 2003

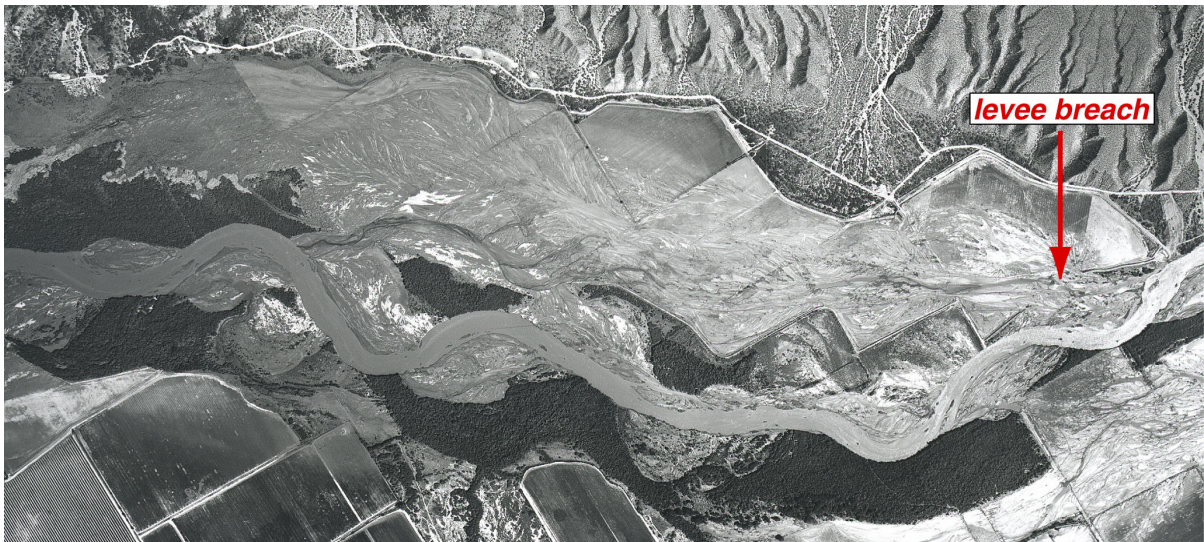
Figure 28. Receding floodwaters, Fort Thomas Bridge, October 7, 1983.

Recent vegetation encroachment in the floodplain from Pima to the San Carlos Indian Reservation also appears to be an important control on active channel morphology and in geomorphic change during floods. As a barrier to flow, thick vegetation may cause erosion of banks with less vegetation during floods. Thick vegetation may increase the likelihood of levee breaches or avulsions by allowing a smaller volume of water to flow through the main channel, (see Figure 28; Hooke, 1996; Burkham, 1976).

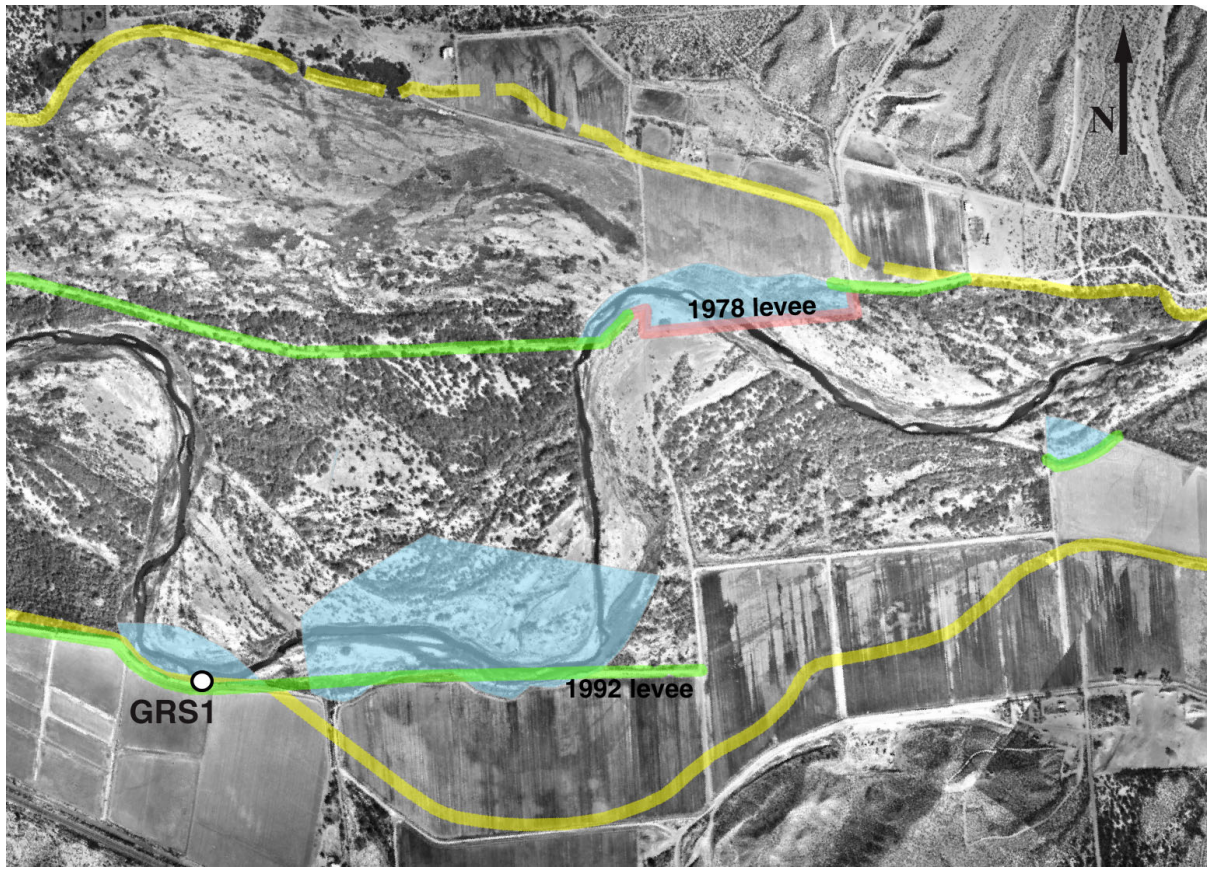
Figure 29. Geronimo geomorphic map.

The Geronimo reach is located near Geronimo and extends downstream to the San Carlos Indian Reservation boundary (Geomorphic Map 1; Figure 29). In this reach, levees on the right bank appear to be most problematic; erosion of these levees during the 1980's and 1990's accentuated the outside bend at this location and directed the river toward the left bank where banks older than 700-1000 years were eroded (see site GRS1). The effect on channel morphology has been a historical increase in sinuosity and a channel with 90 degree bends unlike that of 1935 (Figure 30). Overbank channel splays in farmland on the north side of the river are also evident and caused substantial damage to farmland.

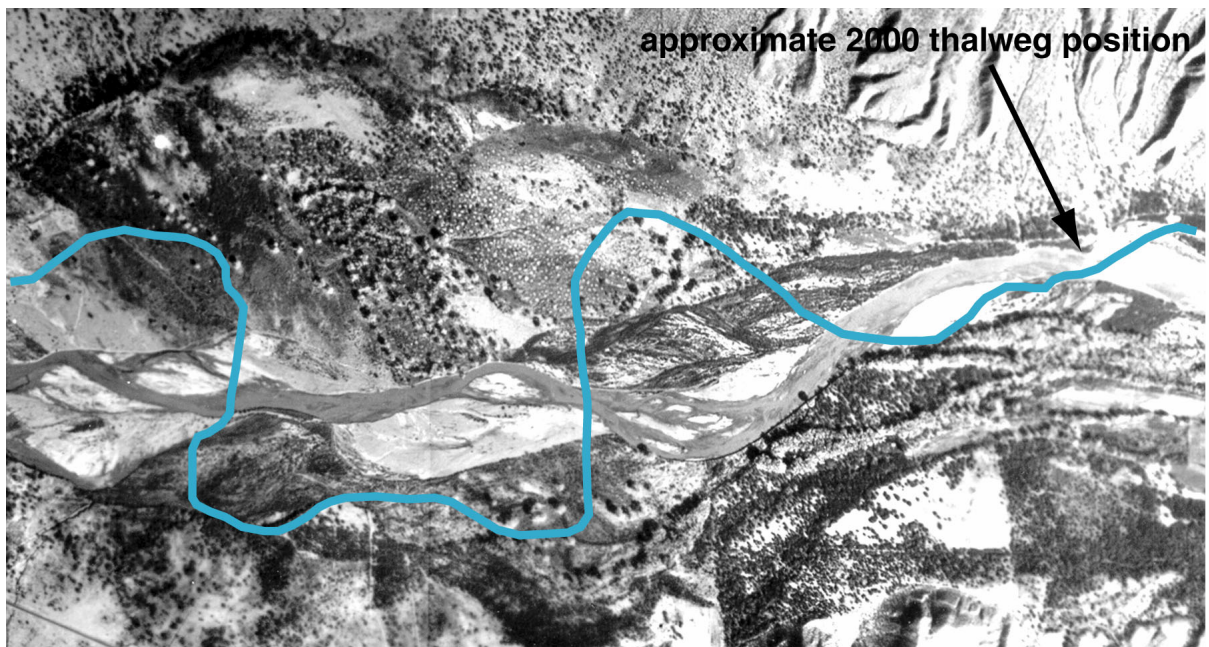
Figure 30. Comparison between 1935 and 2000 channel near Geronimo, AZ.

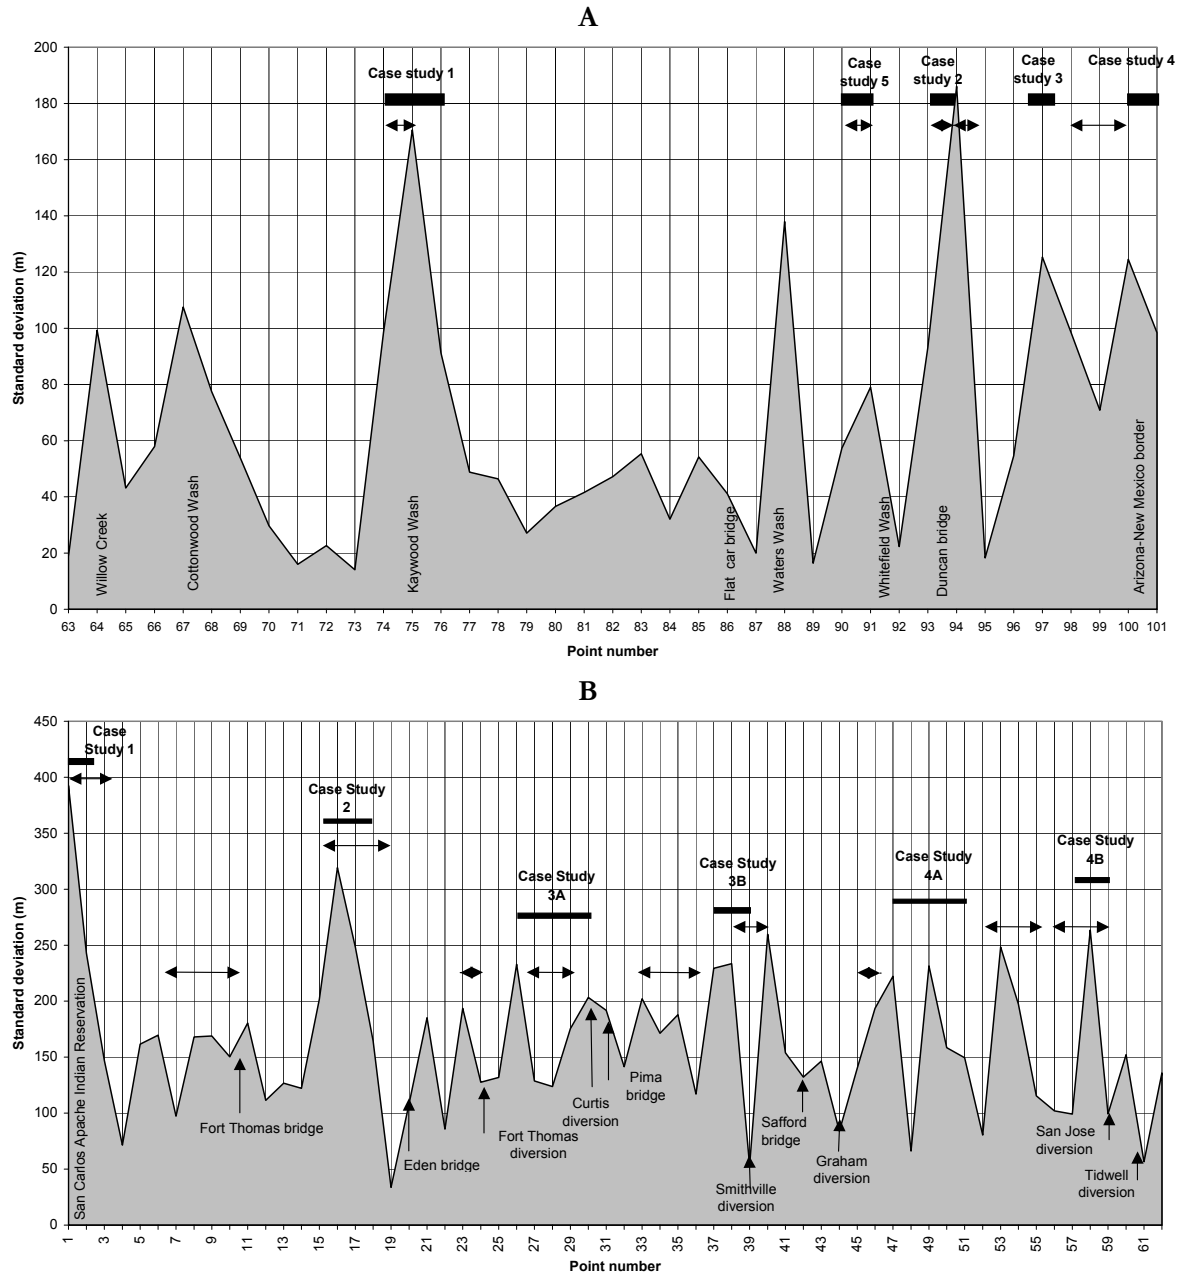
Figure 31. Reach comparison between this analysis and the Catalog of Historical Changes. Case studies refer to reaches in the Catalog while arrows define reached identified in this study.

The geomorphic analysis compares well with the Catalog of Historical Changes (Task 7A) in identifying reaches of channel change. The majority of reaches are the same; however, the Geomorphic Analysis identified additional areas in both valleys (Figure 31; Table 3). The differences can be partly attributed to differences in the methodologies used for each analysis. The Catalog of Historical Changes identifies areas where there has been the greatest variation in channel width from 1935 to 2000. The Geomorphic Analysis documents property loss from 1965 to 2000 in Safford Valley and from 1978 to 2000 in Duncan Valley (Figure 32). This difference in arbitrary datums may be important in explaining differences since land leveling and repeated property loss in the flood channel occurred throughout the historical period. Case Study 4A, downstream of Solomon Bridge, shows an example of substantial historical channel change due to land leveling for agriculture (Figure 33).

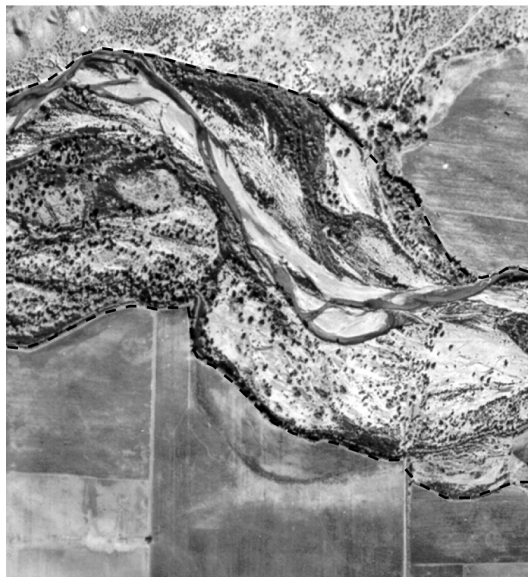
Figure 32. Land leveling near Solomon Bridge.

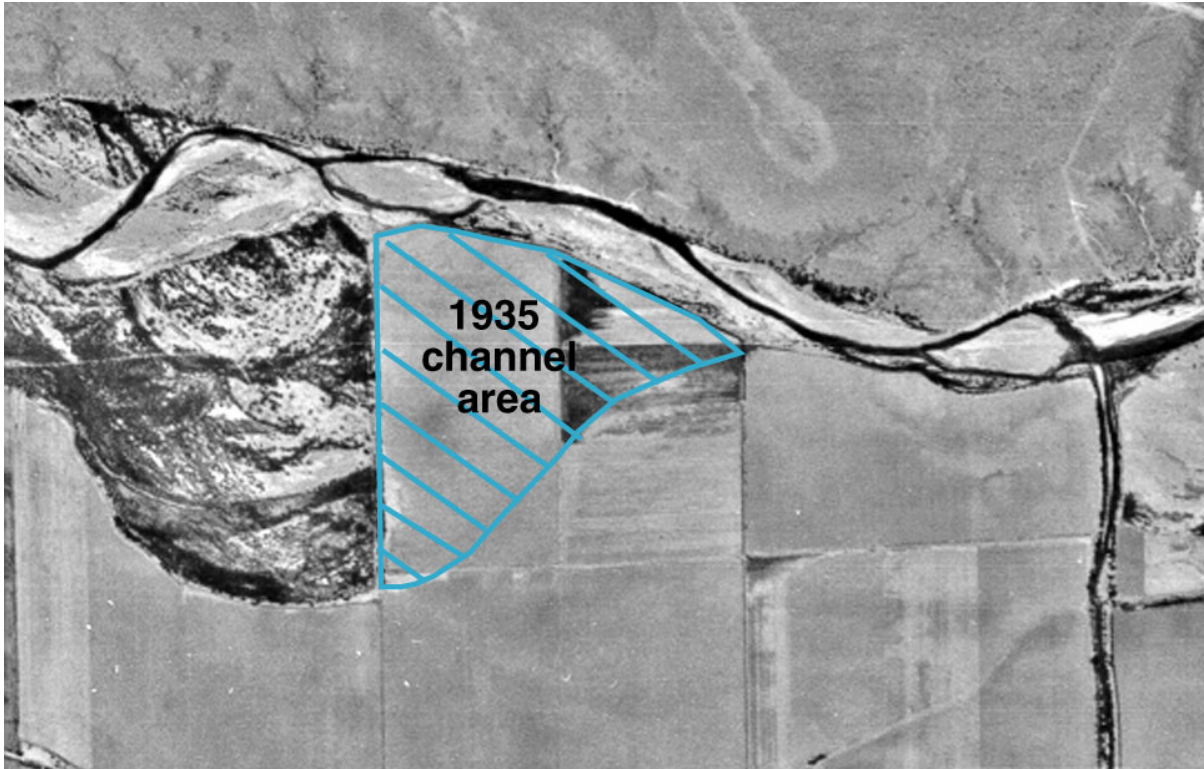
Figure 33. Land leveling downstream of Solomon Bridge.

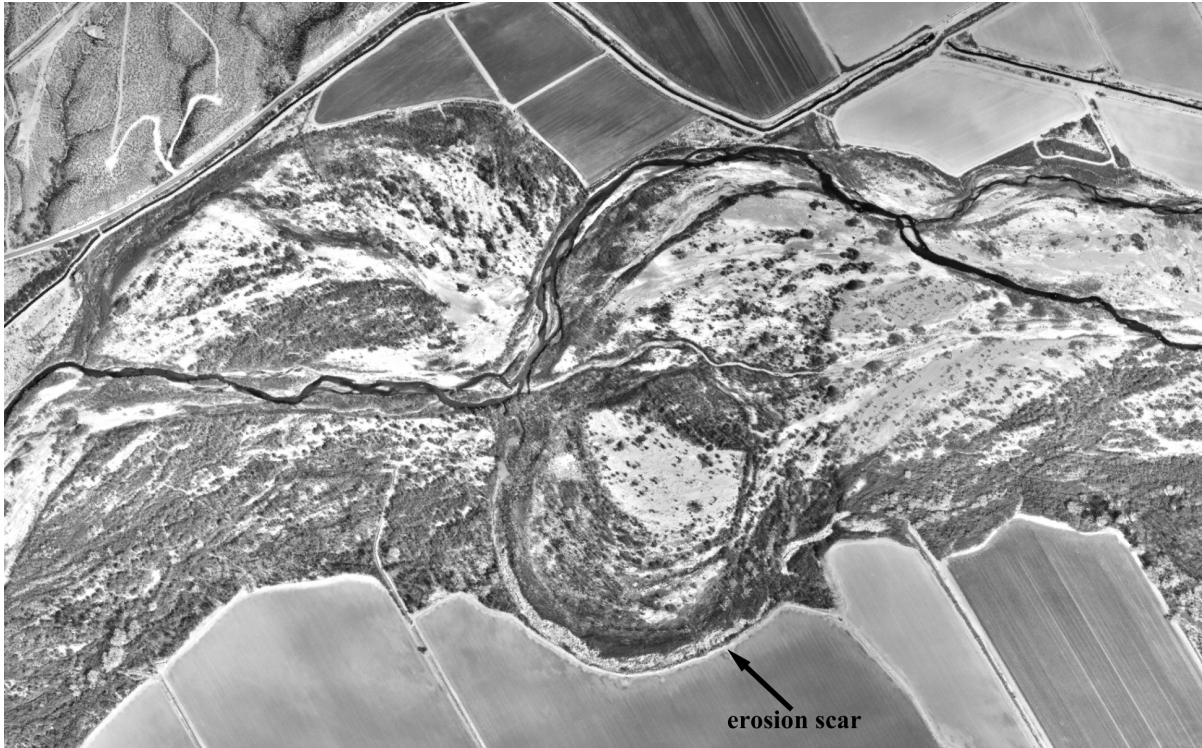
Figure 34. Effects of channel straightening near Curtis Diversion.

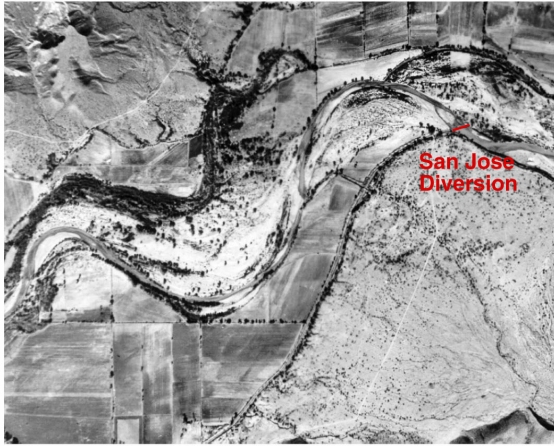
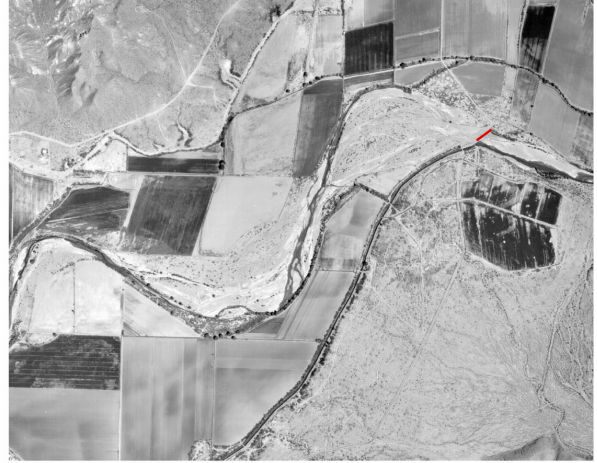
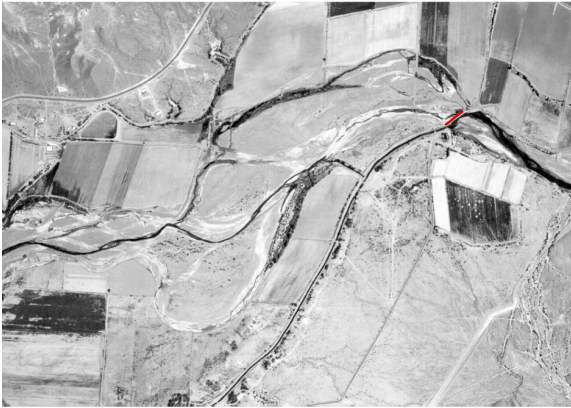
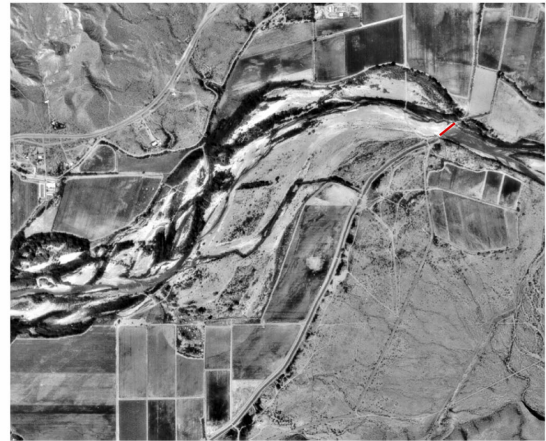
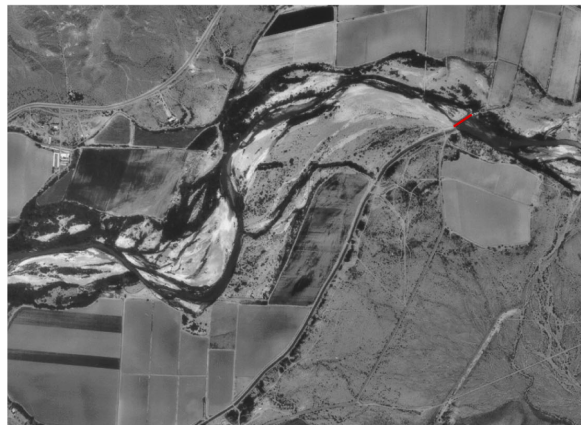
Figure 35. San Jose historical channel changes.

Diversion dam orientation may also cause erosion of opposing banks. This is an isolated case of factor (2), where erosion of the opposing bank does not initiate a propagation of erosion downstream. As water flows over the diversion, it is directed perpendicular to the diversion's orientation. If that direction points toward the opposite bank, then erosion most likely will occur during large floods. A chronology of photos shows progressive erosion of the opposite bank downstream of San Jose Diversion dam inferred

to occur during large floods between the years of the aerial photographs (Figure 35). This erosion eventually forced erosion to propagate downstream into older alluvium.

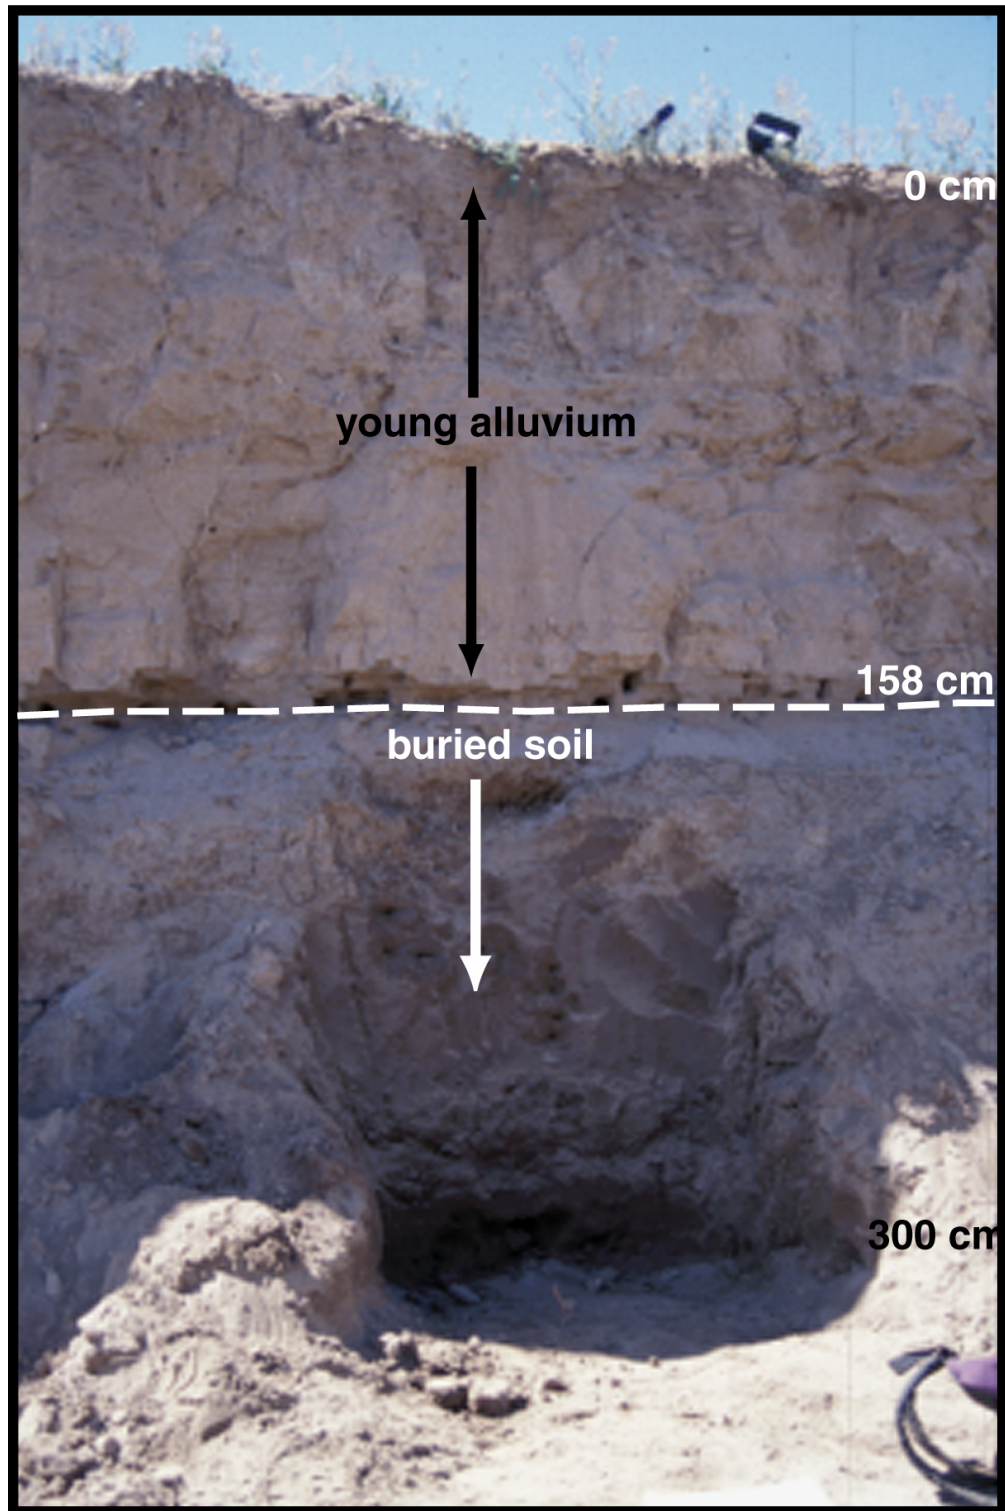
Figure 36. Aggradation at Duncan Bridge.

A few areas of localized vertical changes should be noted. In the vicinity of Duncan Bridge, qualitative observations indicate that there has been aggradation in this reach. Young sediment overlies an older soil in the Gila alluvium on the left bank upstream of Duncan Bridge (Figure 36). This package of sediment appears to thin upstream and thus would be interpreted as a wedge of sediment associated with the construction of Duncan Bridge. Downstream of Duncan Bridge, sediment deposition associated with levee breaches on the left bank over the Pima alluvium is caused by elevated water surface within the levees. Recent channel changes, however, have caused some of the banks of Gila alluvium to be 2 meters or more above the active channel. These high banks are located on outer bends and appear to be localized areas of incision since other areas of Gila alluvium in the vicinity are less than one meter above the active channel. Between Waters Wash and Sheldon, young alluvium is incised but still is experiencing deposition on its surfaces during floods. It is possible that these fluctuations are caused by natural constrictions such as alluvial fans and bedrock, and by the process of vertical accretion. A few areas on
